GREAT NEAPOLITAN EARTHQUAKE OF 1857.

OBSERVATIONAL SEISMOLOGY

TO INVESTIGATE THE CIRCUMSTANCES OF THE GREAT
EARTHQUAKE OF DECEMBER 1857.

ROBERT MALLET, C.E., F.R.S., F.G.S., M.R.I.A.,
&c., &c.

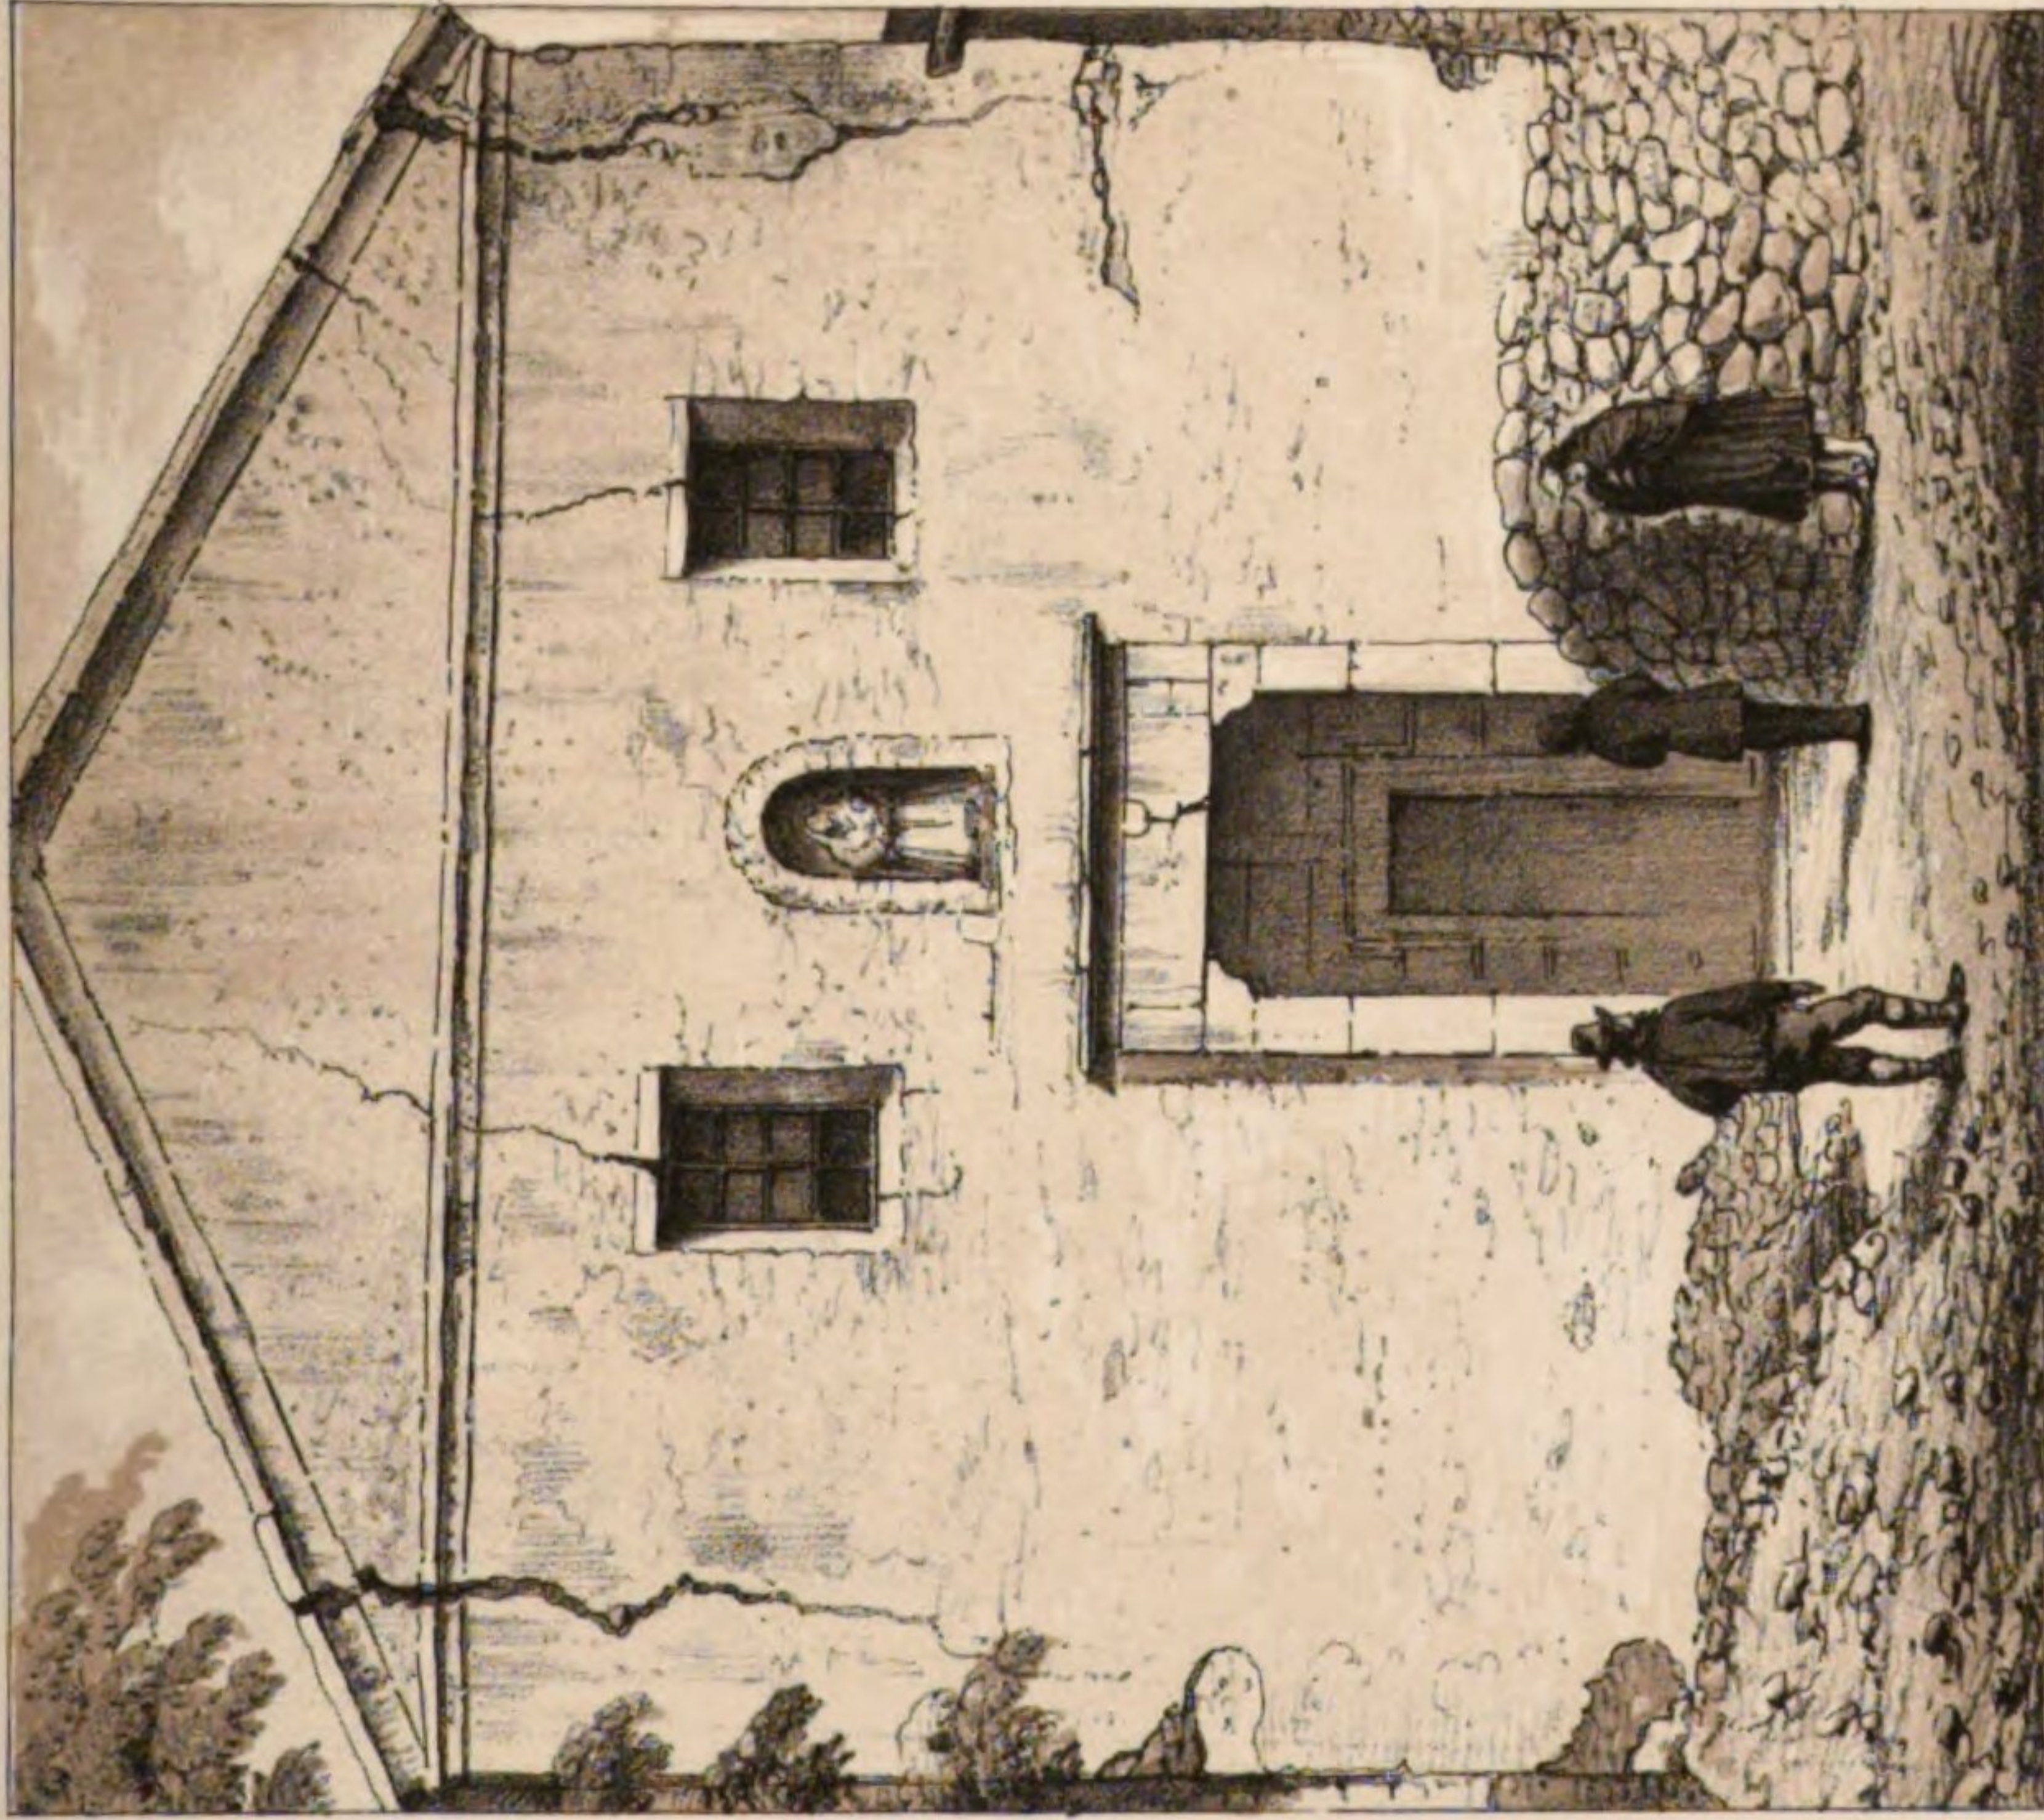
Photo Pl. 25.

The actual phenomena in a well-developed case are illustrated in the Photog. No. 25, which shows the front end of the church of Pertosa, looking at its N.W. end. The direction of the nearly horizontal wave that pro-

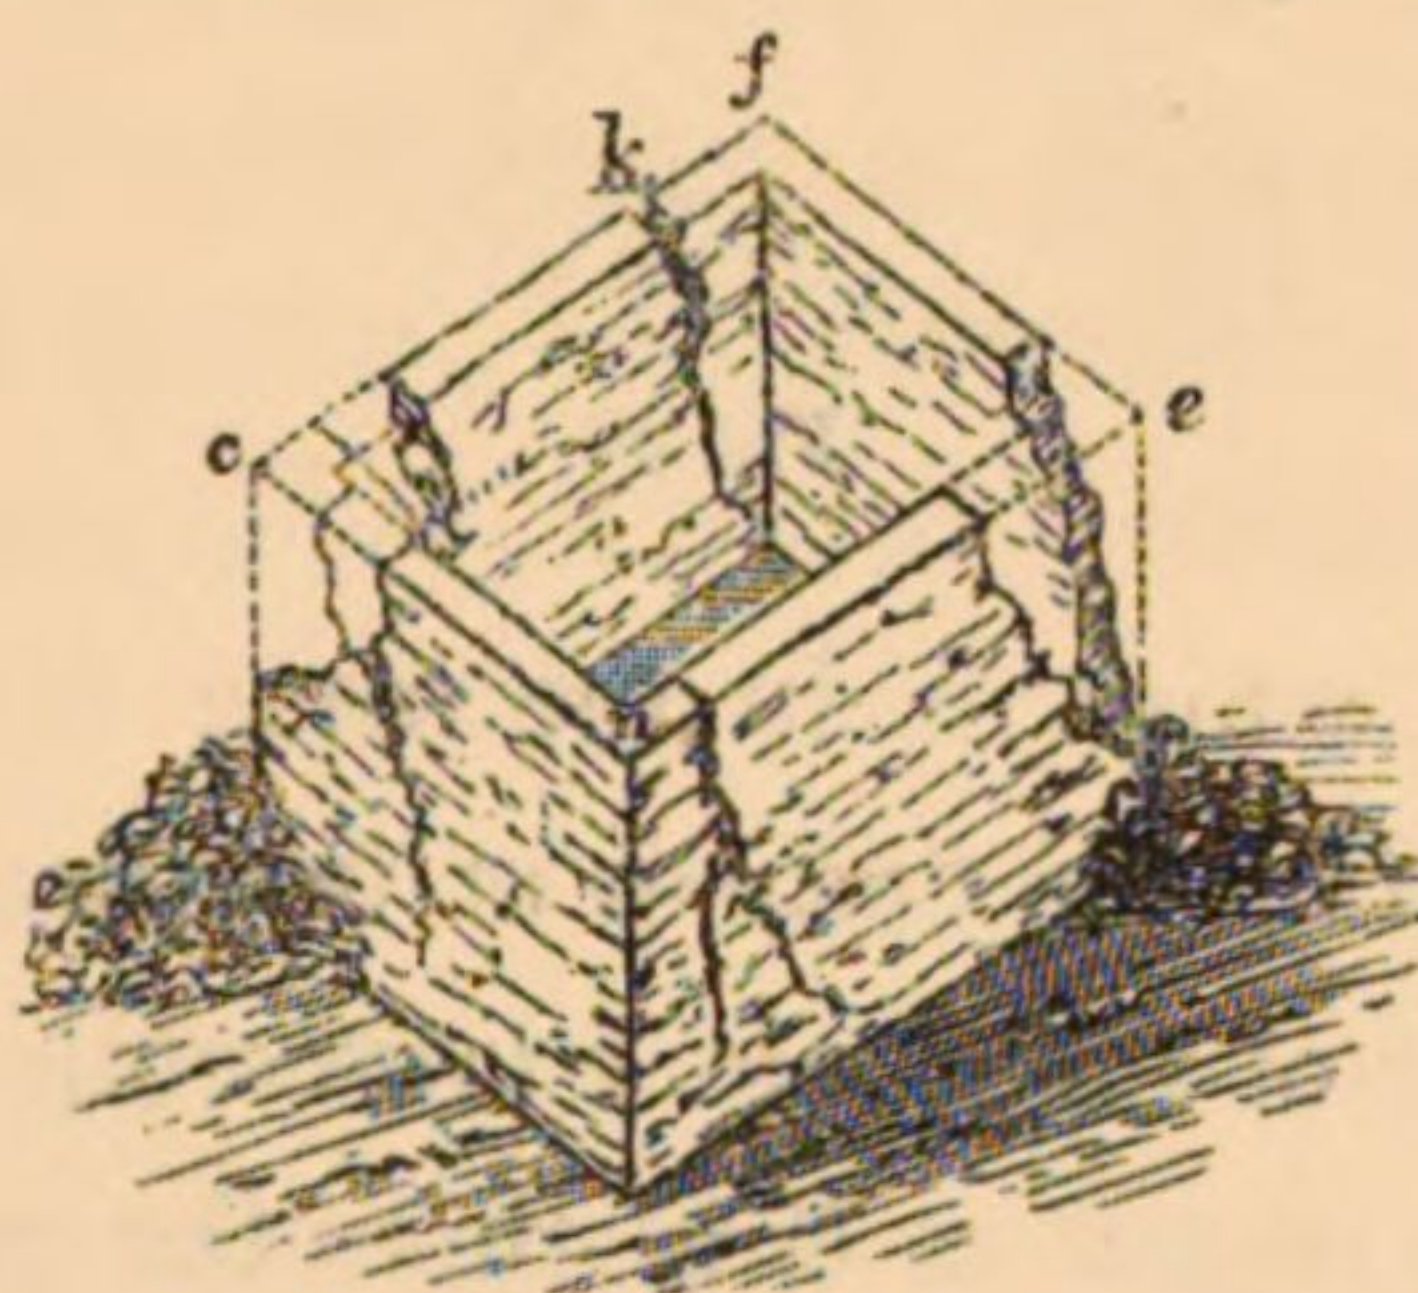
Fig. 45.

At the quoin diagonally opposite, a sort of triangular wedge or pyramid, is either isolated from the wall by fissures, and remains *in loco*, provided the angle of the wedge be such, and the form of fracture also (turning out horizontally at the toe, by an horizontal joint of a quoin stone as at j , Fig 48), as to admit of its stability; or the mass is completely projected, and in that case falls

as debris, in the direction of transit, as shown in Fig. 45, the debris from the diagonally opposite quoin falling in the opposite direction.

Where the force of the shock is sufficient thus for complete overthrow, other fissures are usually formed between c and f and n and e , which *tend* to parallelism with the

main fissures, but are perturbed in direction by torsion, transverse to the plane of these walls. Upon the whole, it seldom happens that much can be learned from the *dimensions* of fissures formed by subabnormal waves; but the angles of obliquity horizontally, abnormal angles, and that of emergence, can be inferred with great accuracy from the form, &c., of the pyramidal mass dislodged from the end e .

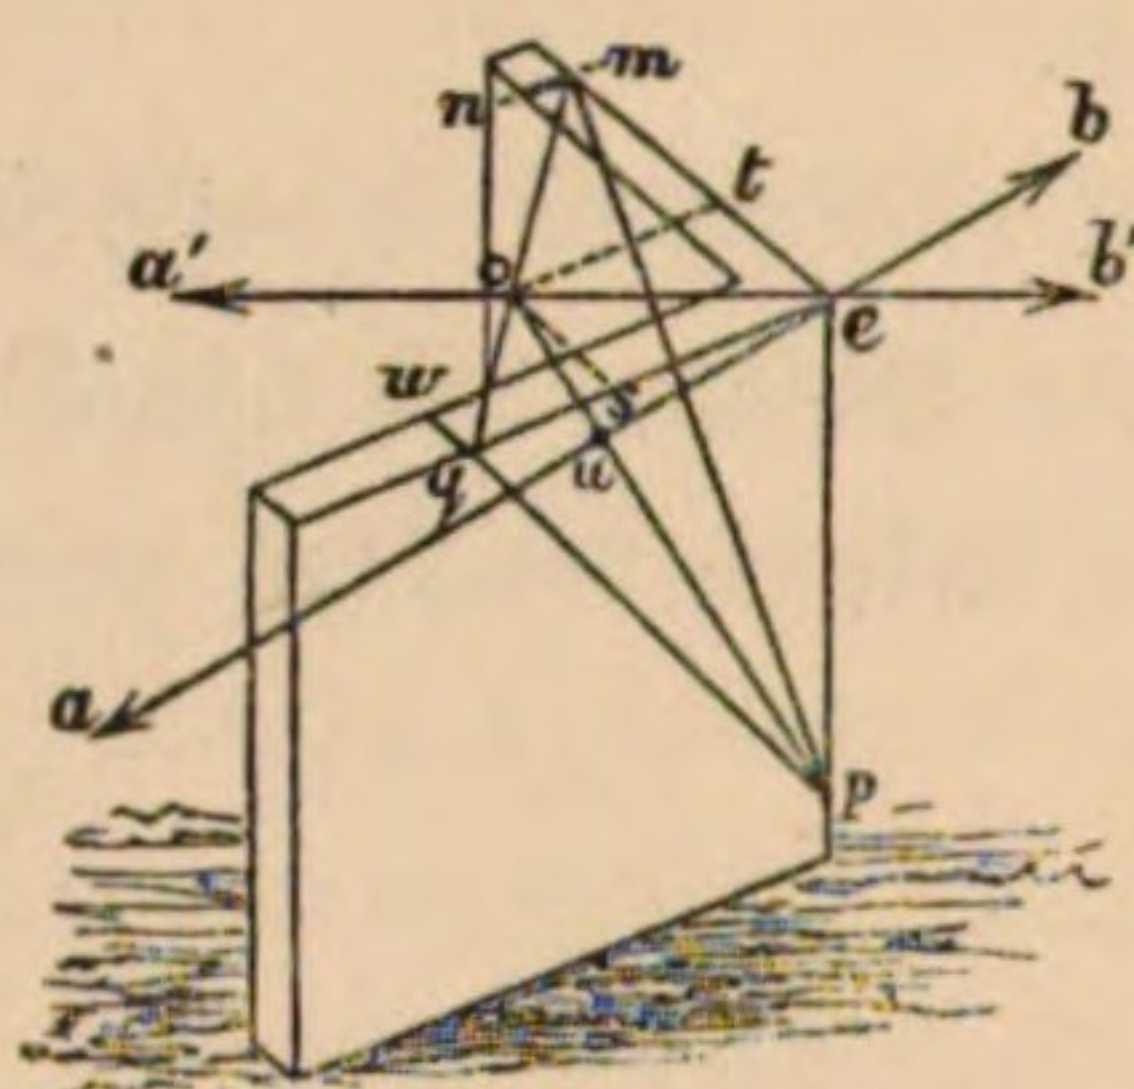
Fig. 46.

Referring to Fig. 46, of a quoin situated as at e , n and w , being the points of fracture, at the summits of the adjacent walls, and p the point in the arris of the quoin, where the two lines of fracture meet when produced.

Join $m q$, then because the mass of matter dislodged in each wall is proportionate to the force acting in the direction of its plane, or to $q e$ and $m e$, draw $t o$ and $s o$ proportionate to these, cutting $m q$ in o ; and draw $a' b'$ through $o e$. This is the path of an abnormal wave,

$a' b'$. Join $o p$, which is in the same vertical plane, and also in the plane of the fissures or fractures, $m p$, $q p$, and through the point of the quoin e intersecting $a' b'$, draw $a b$ perpendicular to $o p$; $a b$ is then the path of the subabnormal wave, emergent in the direction a to b . This is tantamount to finding the resultant of all the parallel forces that resisted fracture, and of course assumes, that the masonry fractures equally readily everywhere.

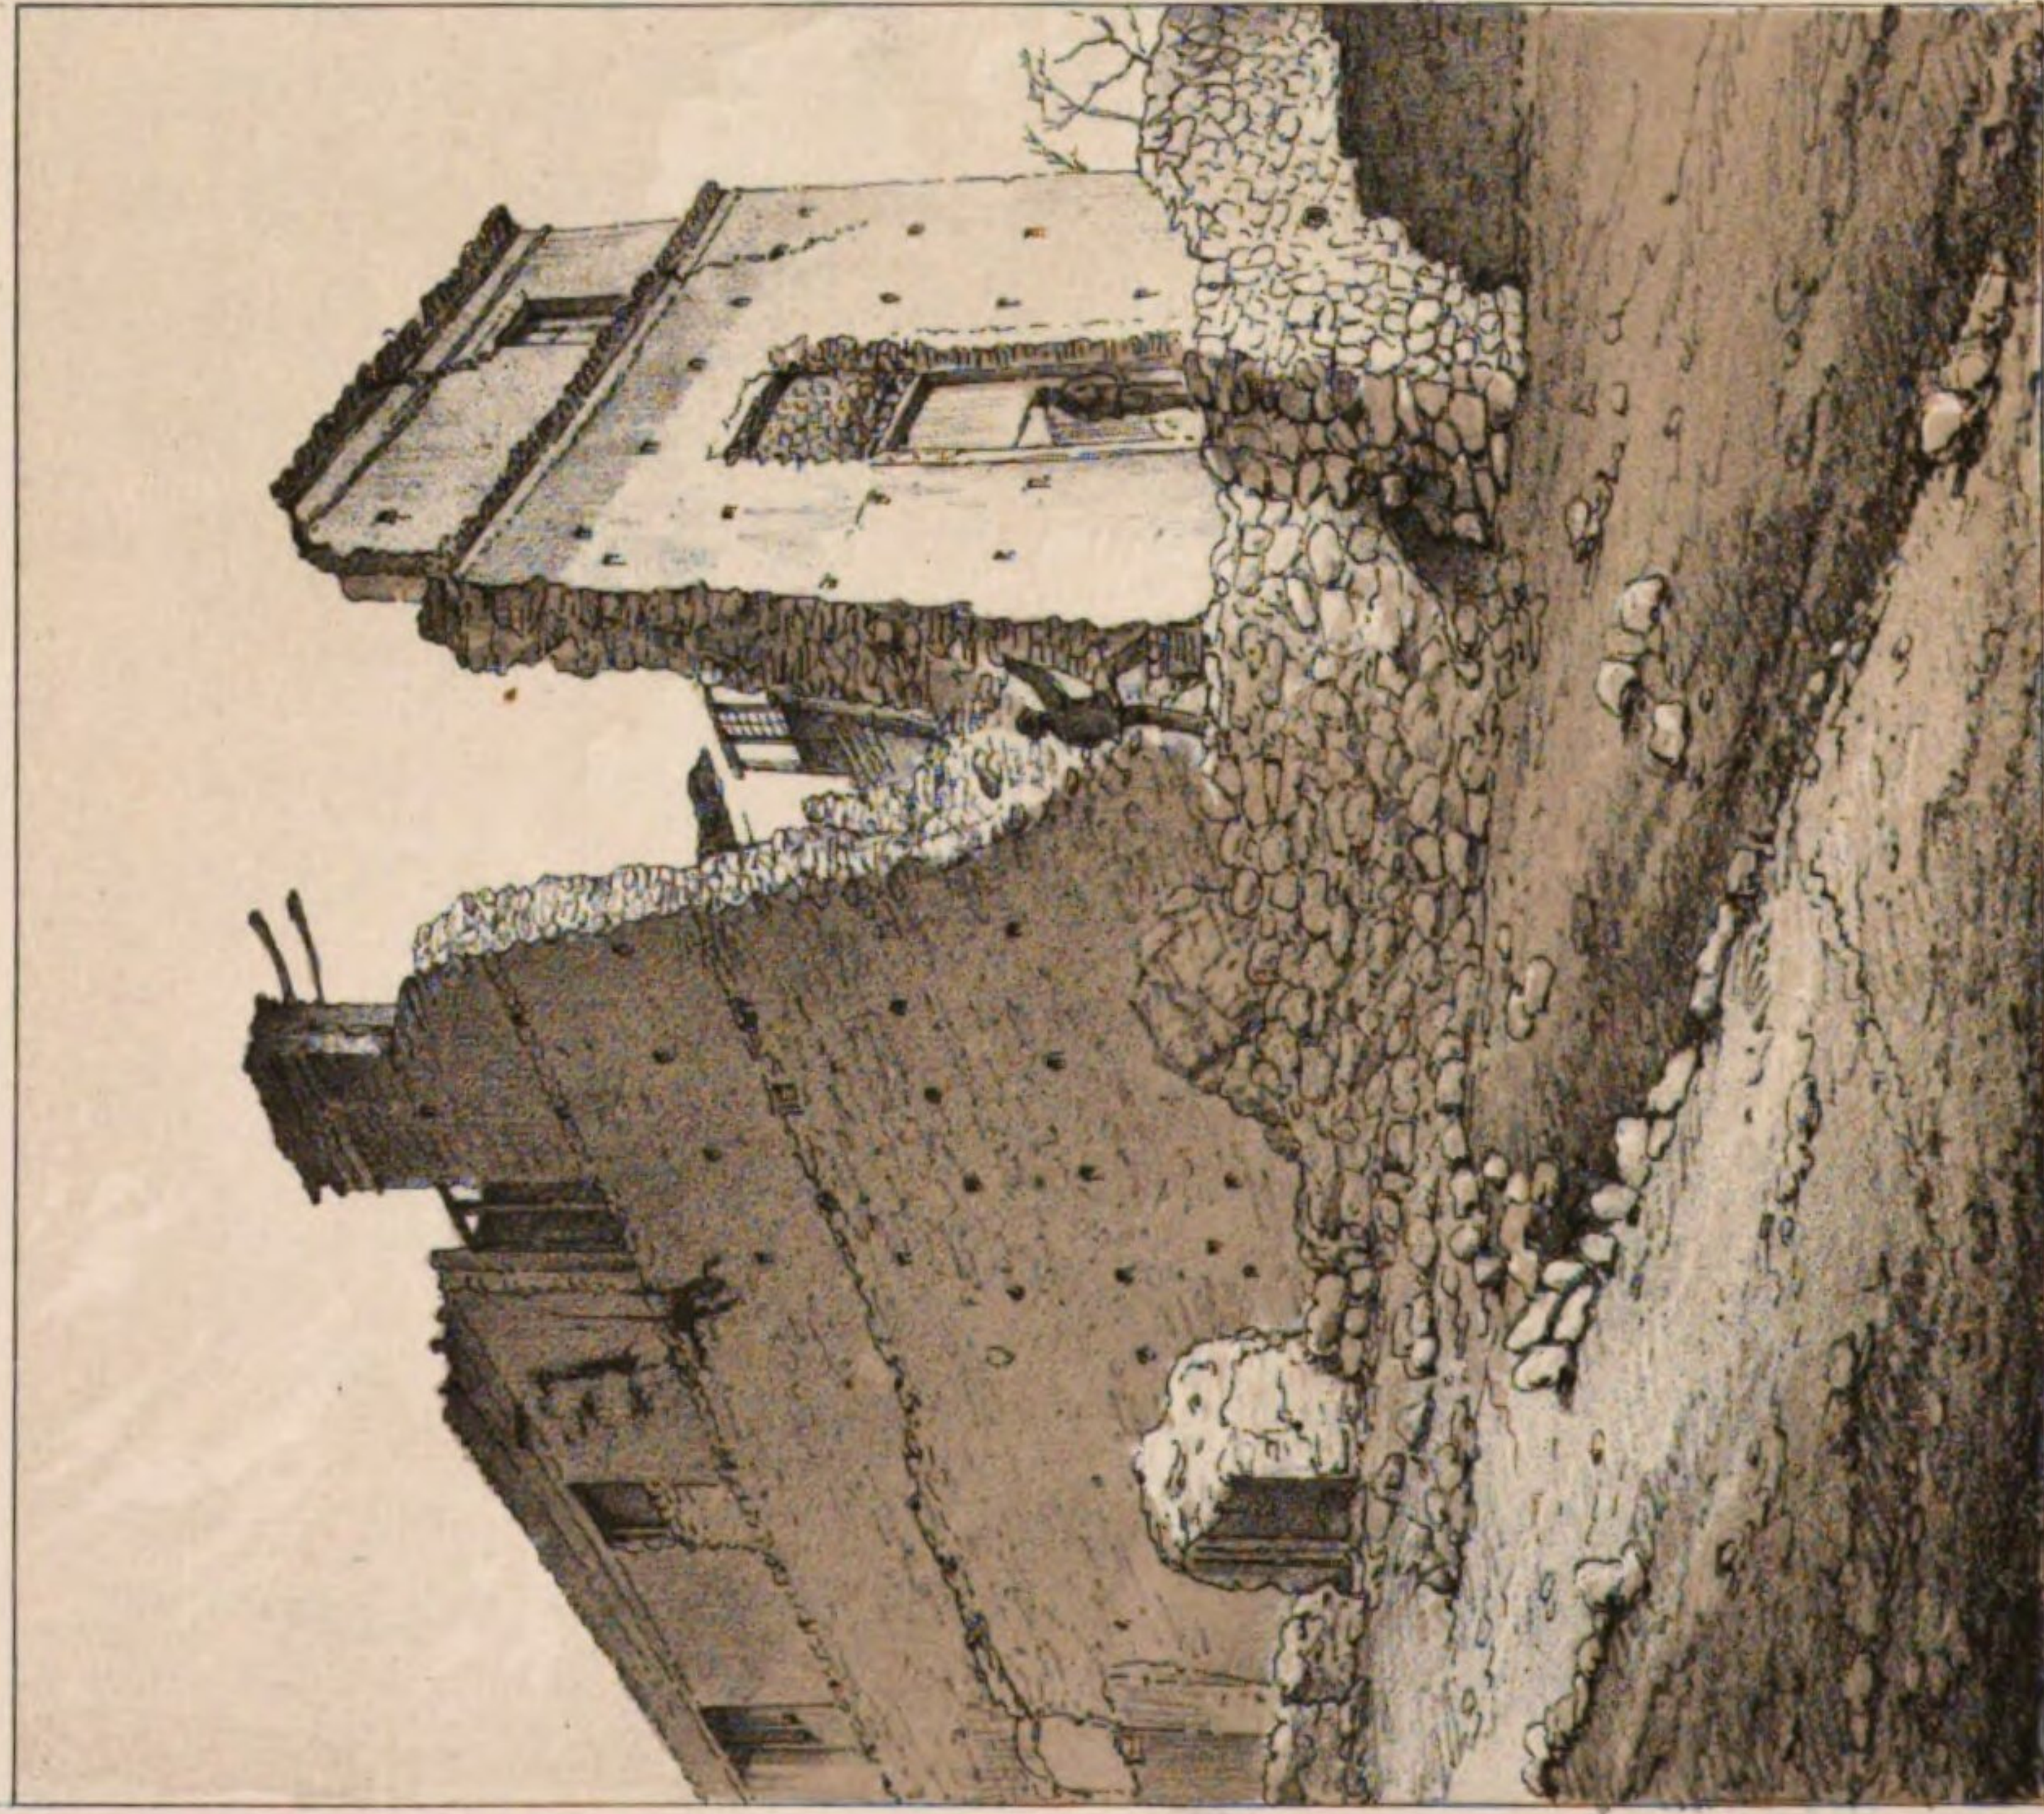
Photo. Pl. 50.

THE CATHEDRAL. PATERNO.

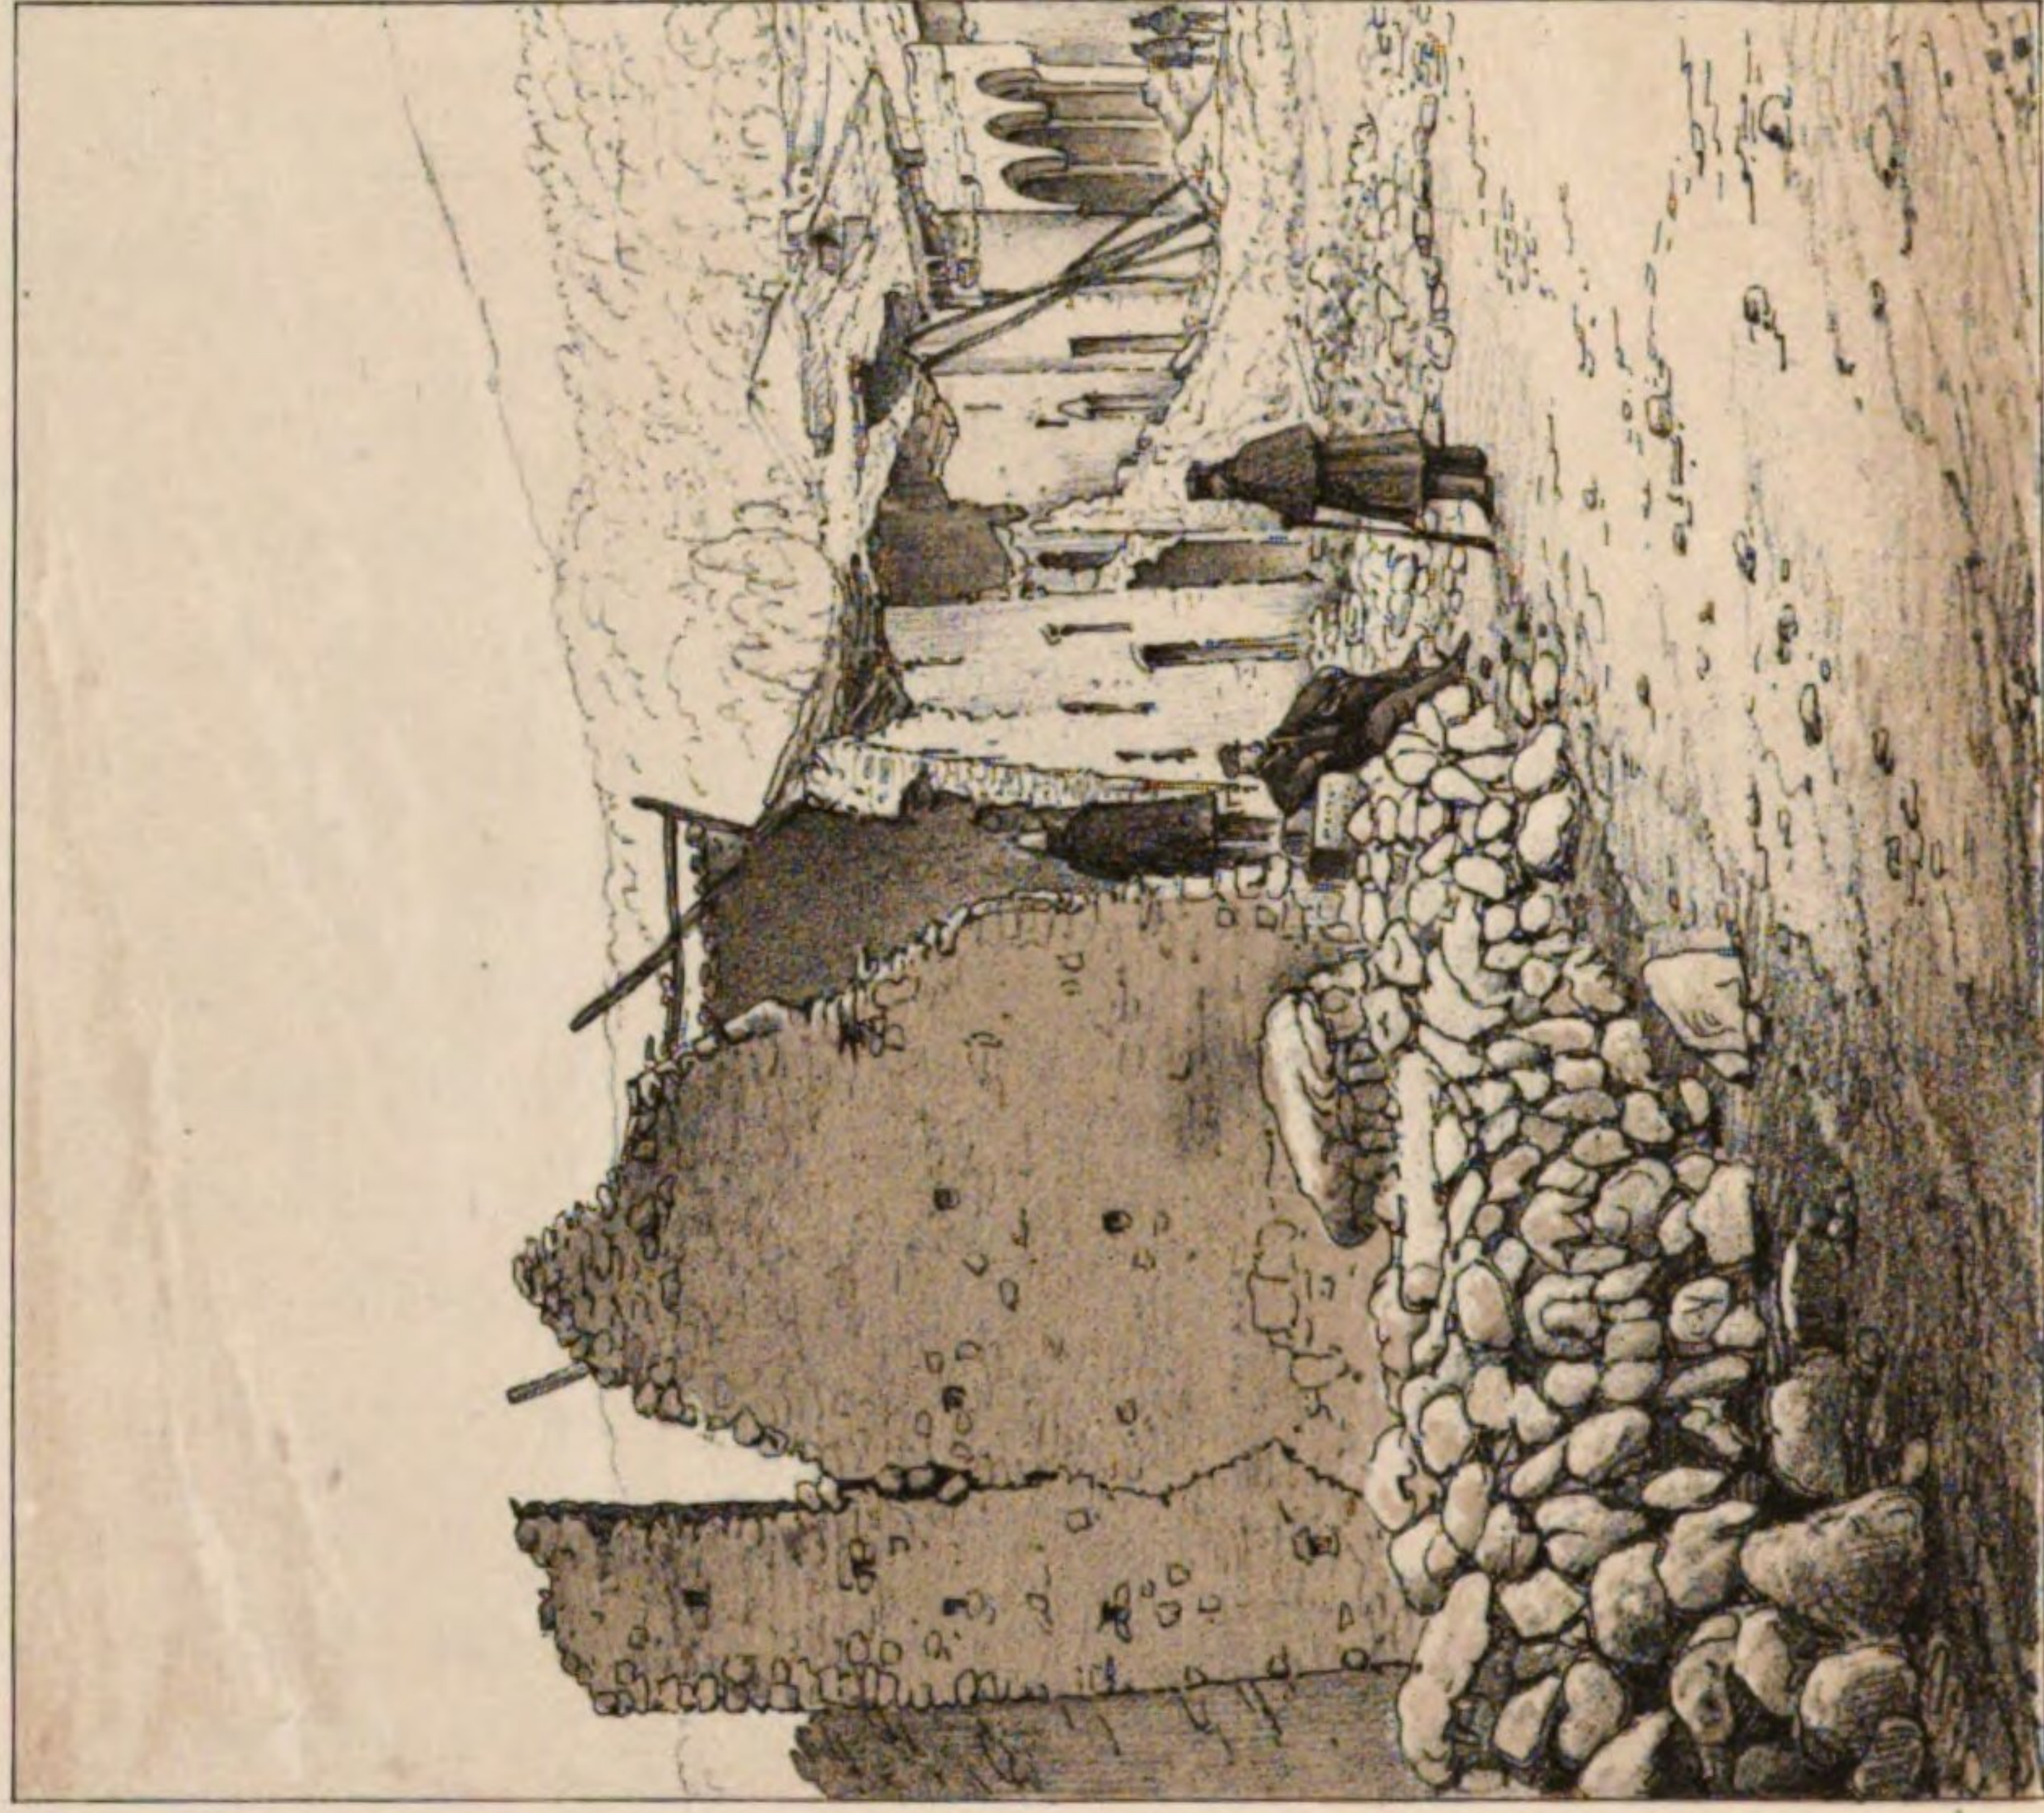
Photo. Pl. 49.

AULETTA.

In the Photog. No. 49, which gives a very good illustration of this class of fracture, as observed at Auletta, this was actually the case. In this view, one of the other large fissures, corresponding to n and k (Fig. 45) may

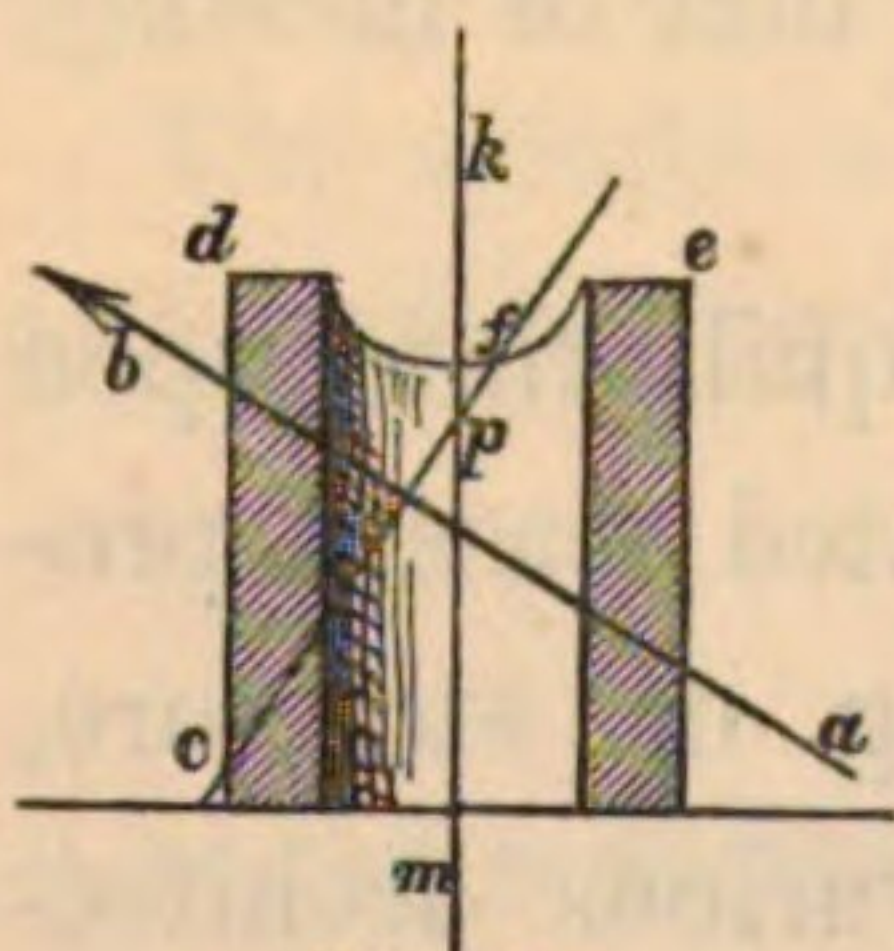
Fig. 59.

such a building, its effects are the same. The distinction of normal and abnormal wave does not exist as respects them; and unless the angle of emergence of the wave be extreme, or nearly vertical, the lines of fracture are the same in every case, viz., vertically through the axis and transverse to the line of shock. This arises from the fact that the area of fracture, and therefore the total resistance, F , due to it, augment rapidly as the angle of its obliquity with the vertical, through the cylindrical walls increases. So that although the direct tendency of the wave $a b$ is to throw off a cylindric ungula, $e d c$ (Fig. 59), by a fracture

perpendicular to its direction in $c f$, yet the surface of fracture is so great, and its direction at either side of the vertical plane of the wave transit, so obliquely through the joints, that the building always parts in the weaker line, by diametrical vertical fissures through $k m$.

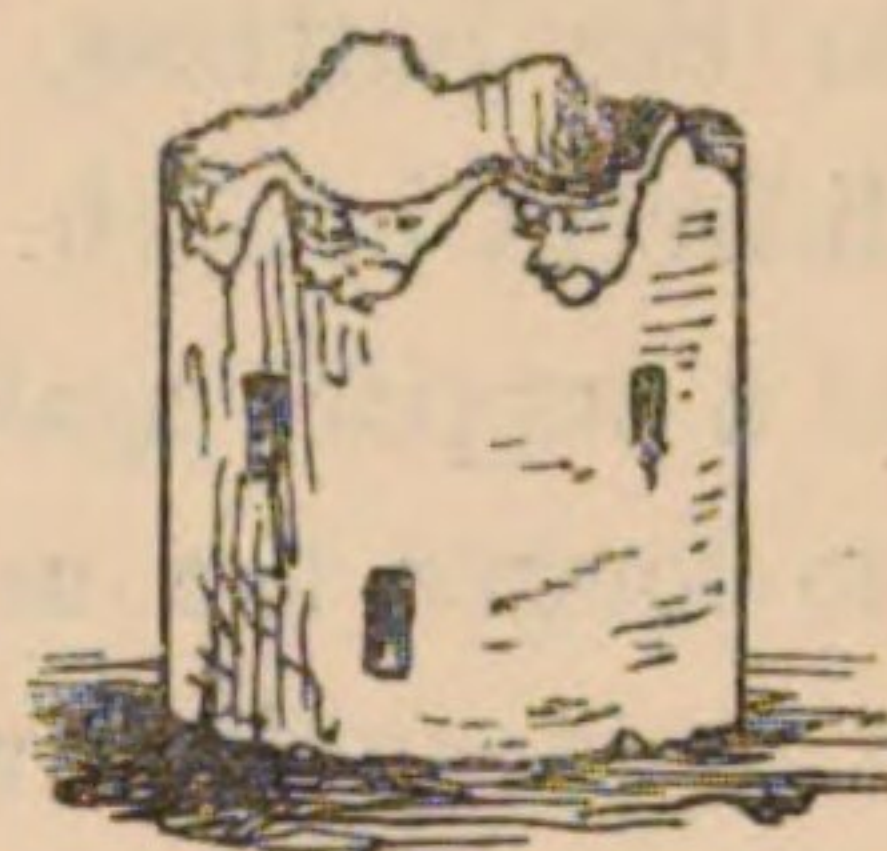
Fig. 60.

form round the top of the walls, commencing vertically, and masses are thrown out, each carrying down with it an ungular-shaped toe, so that the tower becomes shorn around the summit at a greater or less distance down, by the descent of several separate masses from it, in the form of Fig. 60, and, as better seen in the Photog. No. 61, page 42, at Marsiconuovo. The original fissures are here, no doubt, produced chiefly by the twisting movements, transferred quite round the walls, by transversal vibrations as referred to when treating of the wave of vertical emergence.

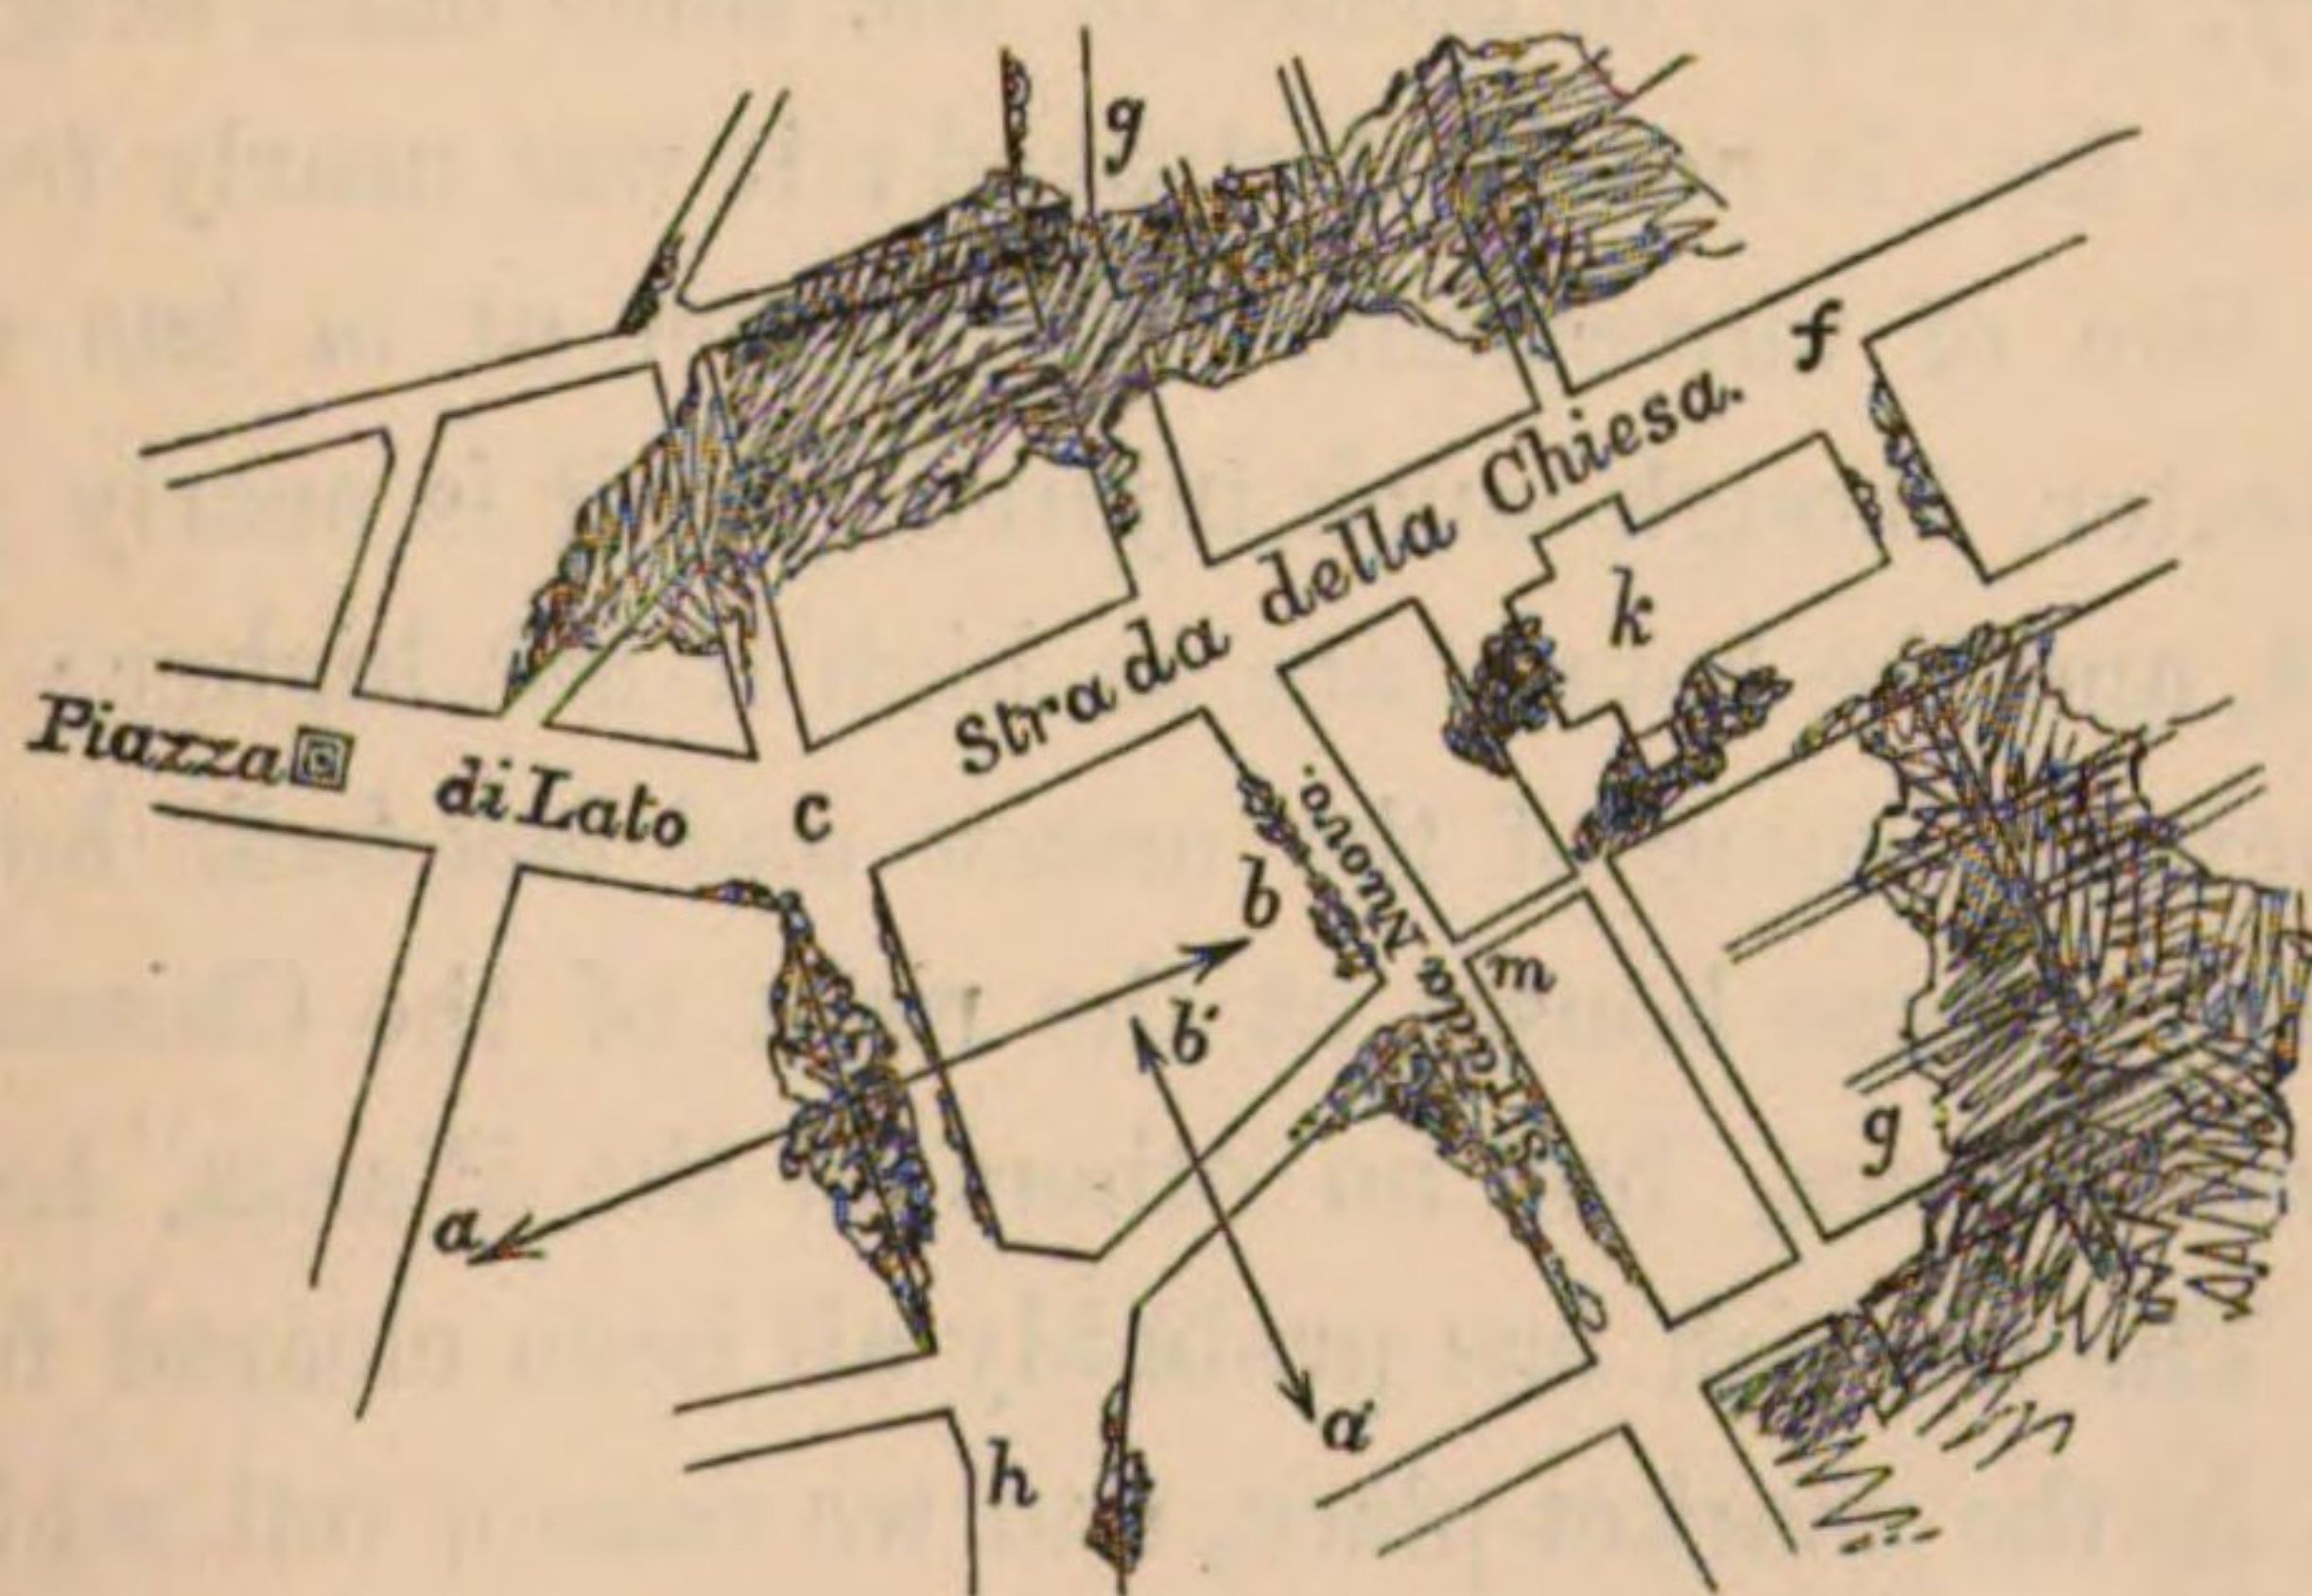
Fig. 65.

of the principal phenomena may be best illustrated by reference to Fig. 65, an imaginary block plan, of part of an earthquake-shaken town. Whole districts at *q q* are prostrated. At both ends of the great church, and about *m*, and along the street from *h* to *e*, houses have fallen, and others are grievously injured; yet these are perhaps amongst the best built and least ancient houses in the place. Passing along the main central street, after debouching over heaps of stone at *e*, it is found, that along the greater part of its length, fissures here and there, a few chimneys, or a side wall down, as we look up some "vico," are all the signs of earthquake visible.

The great church, when examined, tells us that the horizontal direction of shock was from *a* to *b*. Returning now over the ground, and examining the place with the compass in hand, we find that the main street presented *its length* to the direction of movement; its stiff front and rere walls, its multiplied floors, have saved it. The street *e* to *h*, on the contrary, although of houses of the same date, height, and character, &c., is nearly destroyed; it was nearly *transverse* to the line of movement. The street at *m* has escaped much better, though much injured, yet it is nearly parallel with *eh*, and the houses are as high if not higher; but we find they are some of the *newest and best-built* houses in the town. Some houses at the right of the Chiesa Madre are thrown down, but no others in the Piazza, have suffered. The rubbish has probably all been cleared from the Piazza in the market-place, and we cannot tell which way the houses fell, but we look at the fallen apse or campanile or transept, and find that it fell against one of these, and upon these houses. We now get out of the highways of
